## **SEISMIC ASSESSMENT AND STRENGTHENING OF AN EXISTING STEEL BRIDGE IN PORTUGAL**

This article presents the seismic vulnerability assessment of the S. João de Loure bridge, in Portugal. The single span steel bridge has riveted joints, commonly affected by corrosion, which can lead to a significant stiffness reduction. With the objective of evaluating the influence of the joints stiffness in the structural response of the bridge, a structural model of the bridge was created, and natural frequencies, maximum axial forces and maximum stresses, and maximum mid-span deflection were analysed. Four possible element rupture scenarios were also studied. Two of them were proved to be a risk for the structural safety of the bridge. A commonly used strengthening solution intending to reduce the bridge's mid-span deflection with external pre-stressing cables was studied.

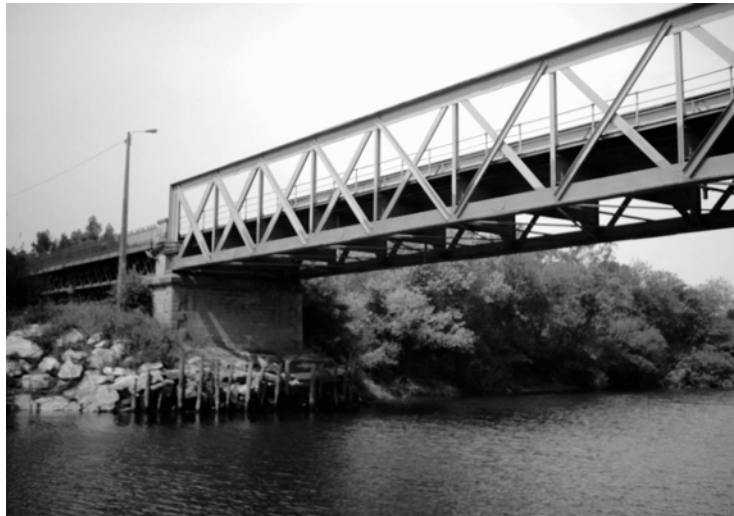
Figure 1. General view of the S. João de Loure bridge (Furtado et al., 2003)

The S. João de Loure bridge under analysis (Figure 1) is located in S. João de Loure, district of Aveiro, Portugal, and it is a part of the national highway EN 230-2.

The bridge has a single span with approximately 43.36 m. Eleven panels can be identified, each with a length of 3.54 m. Table 2 summarizes the main geometrical characteristics of the bridge. The connection between elements is assured by rivets, as shown in Figure 2. The main structure is supported by two different types of bearings located in masonry abutments: fixed supports in the north abutment (Figure 3) and roller bearings in the south one. At the level of the bottom flanges, a bracing system guarantees the protection against lateral torsional buckling (Figure 4).

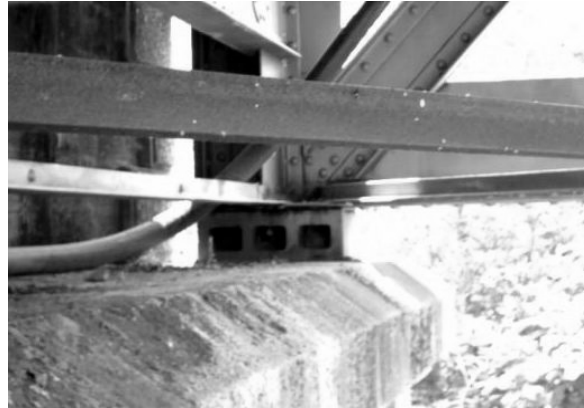
Figure 3. Fixed support in the north abutment (Furtado et al., 2003)

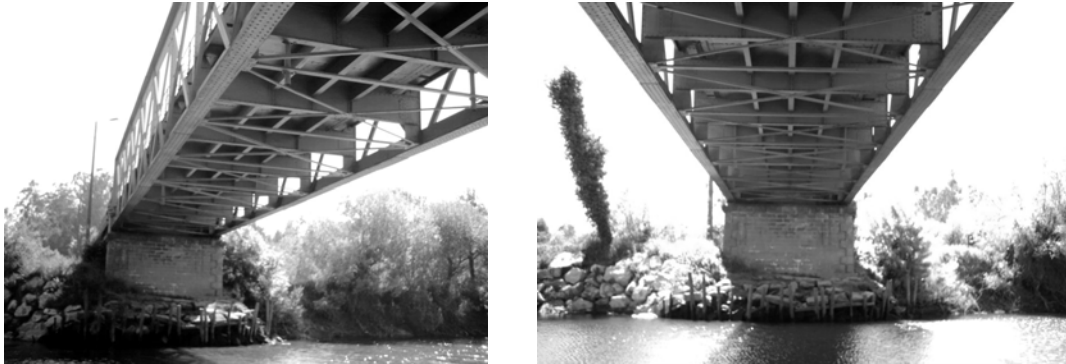
Figure 4. Bottom views of the S. João de Loure bridge: bracing system (Furtado et al., 2003)
